# DuPont™ ISCEON® MO99™

## CASE HISTORY

### ISCEON® MO99™ (R-438A) REFRIGERANT IS A PERFECT MATCH FOR PHOENIX HEAT

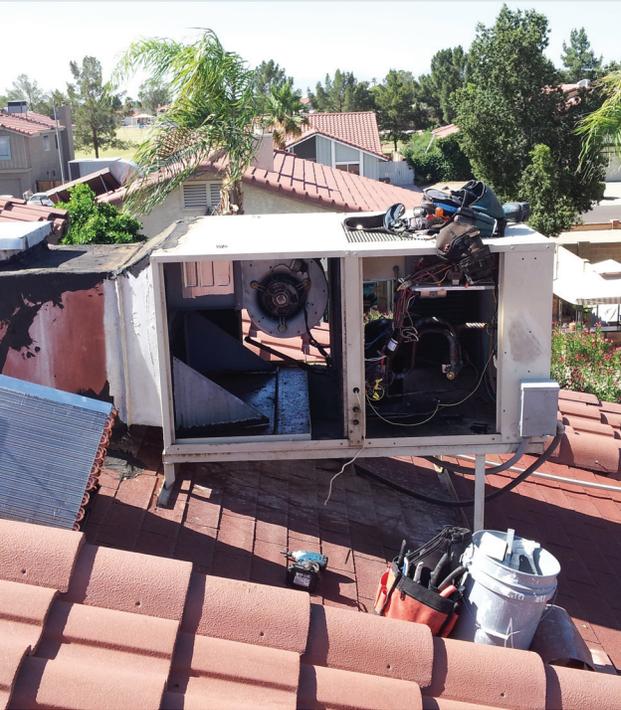
**Retrofit of an R-22 roof-top heat pump in Phoenix, AZ to MO99™. Kirk Buscho and his team at North Valley Mechanical have converted over 50 units to MO99™ so far.**

As a last attempt to salvage the unit for the homeowner, Kirk devised a plan to retrofit to DuPont™ ISCEON® MO99™ refrigerant. He anticipated difficulty in locating parts for this unit. The old coil needed to be replaced but a new one was not available. A custom created coil could be ordered, but proved to be cost-prohibitive. Kirk identified another shape of coil that matched the old one in both size and tonnage. His field superintendent, Robert Forbes, configured and assembled the evaporator, including new air baffles on each side so that air would flow properly through the coil. Also, during the retrofit, the old piston orifice was changed to a thermal expansion valve (TXV).

With regard to the ISCEON® MO99™ conversion, Kirk stated, “On a package or split system, we’ve found you only need to replace valve cores and caps, as they have elastomeric seals. There’s no need to replace Teflon® or nylon rings.” After replacing the seals, he changed the filter dryer, evacuated the system to 500 microns, and charged the unit with ISCEON® MO99™ refrigerant, with a weight just under the original system specifications. After allowing the system to stabilize, he added approximately seven more ounces of refrigerant.
